Confidential Inspection Report

SEPTIC SYSTEM DESCRIPTION

WELL DESCRIPTION

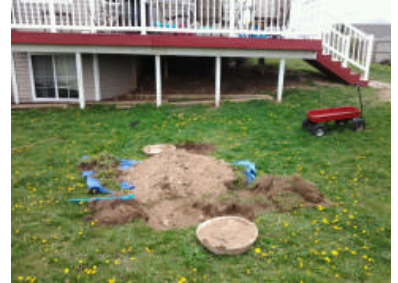
TYPE OF TANK #1: The septic tank on site is a concrete double chamber tank. This type of tank is designed to keep the solids in the front chamber and away from the effluent pipe. This will keep the solids from getting out to the drain field and causing blockage or failure.

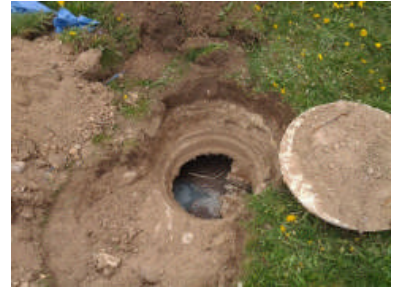
DEPTH OF TANK: Less than 18"-satisfactory.

CONDITION OF LIDS: Satisfactory.

CONDITION OF TANK: Satisfactory.

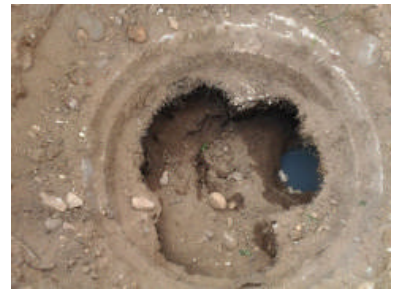
SCUM THICKNESS: 6" scum with 1" scum in rear chamber.

SLUDGE OR SOLIDS THICKNESS: 7" sludge with 2" sludge in rear chamber.

PUMPING RECOMMENDATIONS: The tank needs to be pumped immediately. There are heavy solids noted in the front chamber of the tank. The solids noted in the rear chamber can make there way out of the tank and in to the drain field. This can cause pre-mature failure of the system.

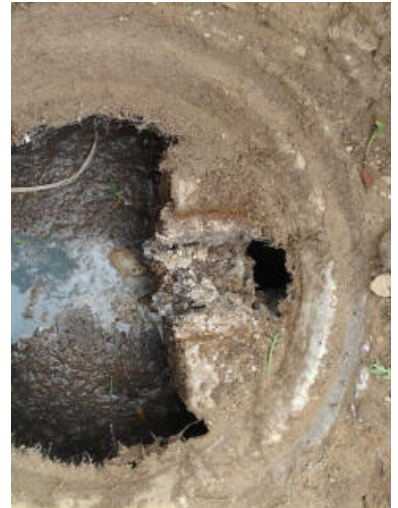
There is not a filter present on this system. Installing a filter at the outlet effluent pipe can help keep solids from entering the drain field and causing blockage or pre-mature failure. This tank does have a concrete outlet baffle which helps separate solids. The baffle is starting to corrode but is functional.

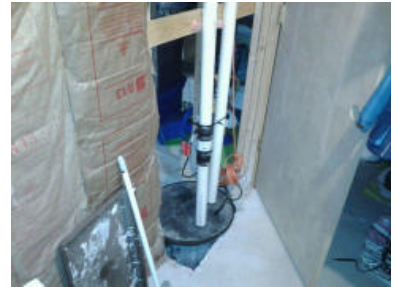
Sewage ejector pump in basement. Functions and discharges to primary system. Basin is not secure in concrete floor. Recommend filling void area with concrete.

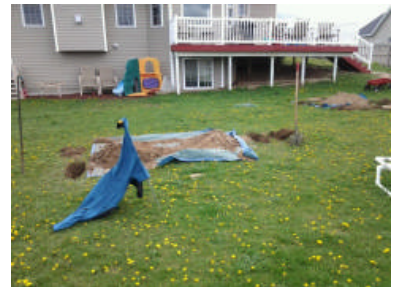
Conventional bed system.

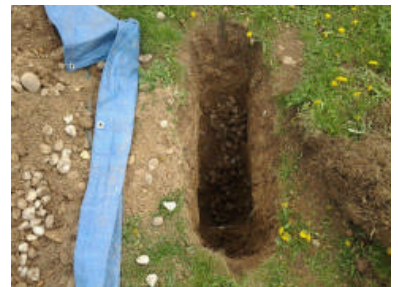
Auger holes or trenches were advanced to access and inspect the condition of the gravel bed.

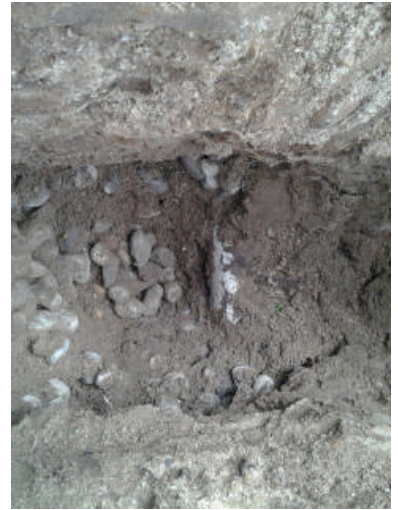
Pooling of effluent noted in the drain field stone below the tile line in the second trench put down in the drain field. This is an indicator of heavy or extended use. Dirty stone was noted beneath the tile line. This can be a sign of advanced wear. This drain bed is relatively young in age but the stone and conditions noted in the field are not in line with what would be expected for a system of this age. Due to the very large number of occupants this system has had more use in its early stages than a typical drain field. The system is properly functioning and shows no signs of immediate failure or malfunction but it must be noted that the system has been overloaded for some time do to the large number of occupants in the home.

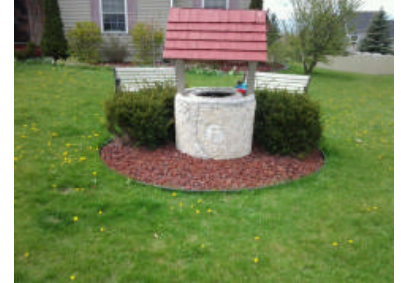
Front yard.

Well Head Condition: The exposed portion of the well head and cap are in satisfactory condition.

Well Head Height Above Grade: 12" or Greater-This is the recommended height per Michigan State Well Construction Code.

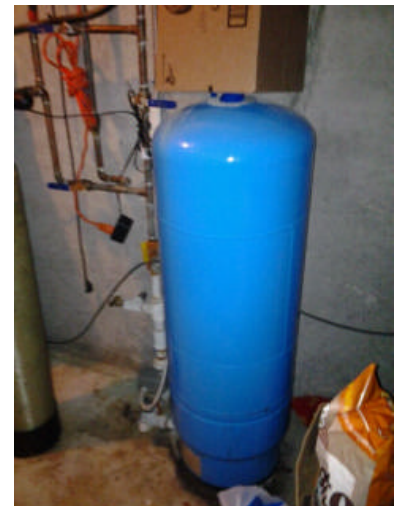
Basement.

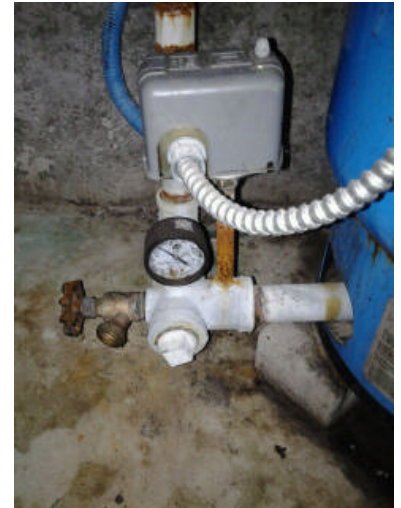
Pressure Gauge Present: Yes, there is a pressure gauge present on this system.

Is the Pressure Gauge Operational: Yes, the pressure gauge is operational.

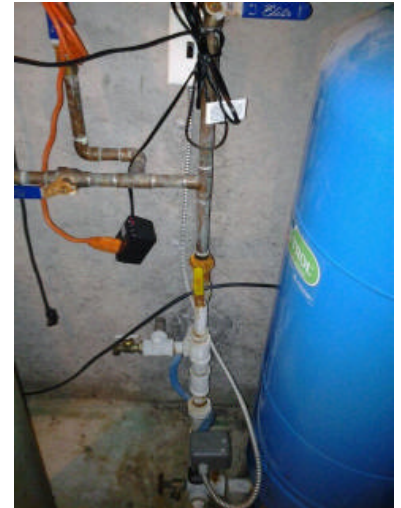
Is the electrical system safe and adequate? The visible portion of the electrical wiring associate with the well system appear to be in satisfactory condition.
